**ALL SAINTS' CHURCH  
CLIFTON  
BEDFORDSHIRE**

**QUINQUENNIAL REPORT & RECOMMENDATIONS**

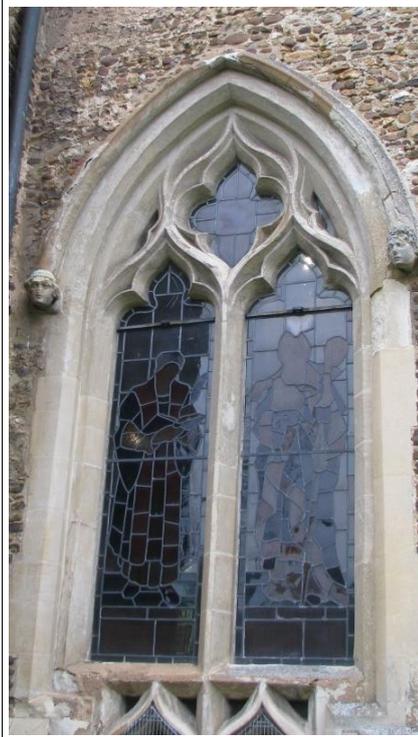
The stonework to window W3 is in a poor state in parts. The hood mould appears to have had previous render repairs which are either themselves failing or as discovered recently on the East window the render is merely masking the state of decay of the stone behind, and is the highest priority. The stone to the lower rail and jambs is in need of attention but less urgent.

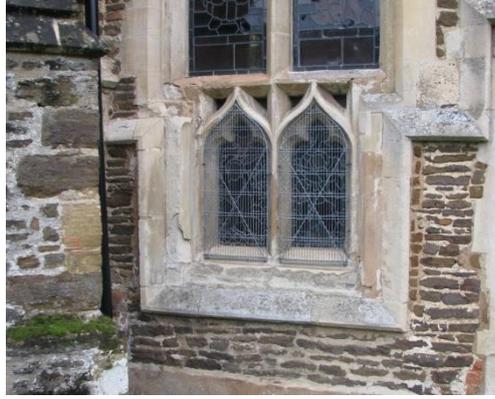
The cementitious render to the base of part of the South Chancel wall is in poor condition in parts and should be removed and the underlying stonework made good.

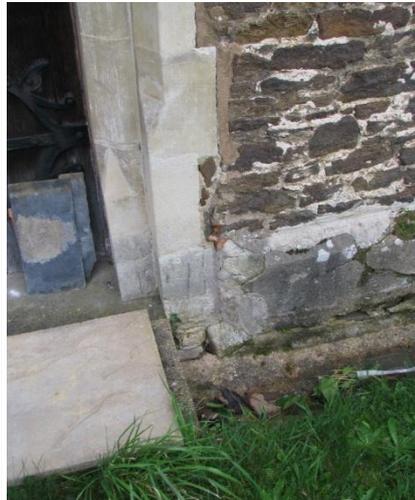
Exposed open joints in exposed stonework at low level and Buttress B4 require repointing

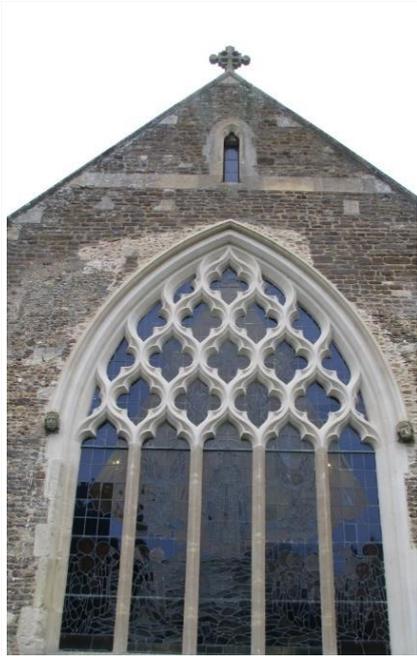
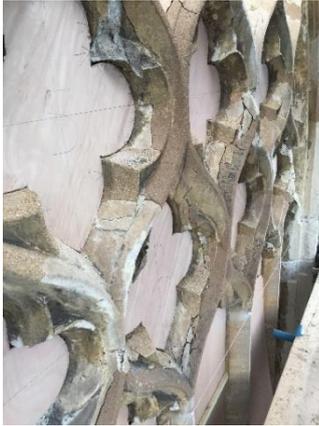
The external upper tracery, hood mouldings and sections of the jambs to the East window (W6) were repaired in 2017 by Hibbitt Stonemasons.

(Completed & at QI shown on left – close up of condition of tracery during 2017 works – right)

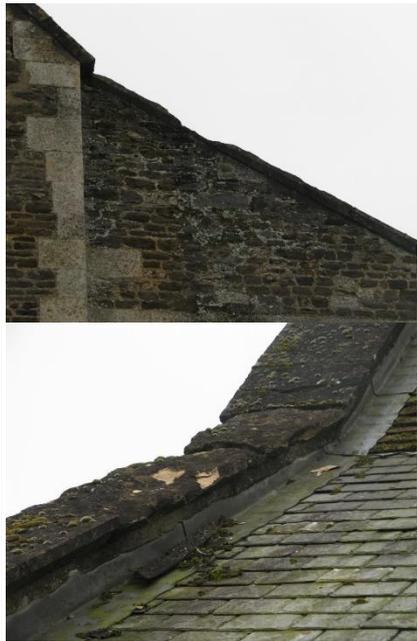
The coping to the upper section of the east parapet gable over the chapel is in poor condition and requires repair/replacement. There are signs of movement to the quoin at the eaves which requires attention and monitoring, and moss growth to sections of the wall that should be brushed clear as elsewhere.

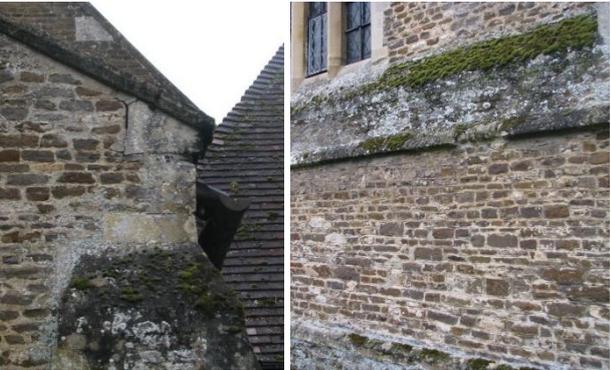
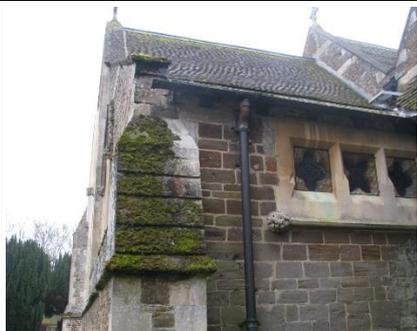
Again, Moss growth to the north wall to the Chapel and east wall to the Vestry should be brushed clear.

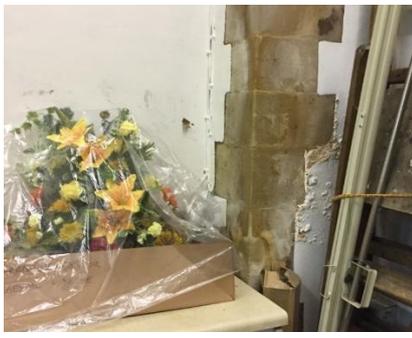
<p>Internally the south-east corner of the vestry shows signs of damp penetration. The rainwater hopper and downpipe externally are again the most likely source. Monitor, and make good after resolution of the issue externally.</p>	<p>5/3</p>

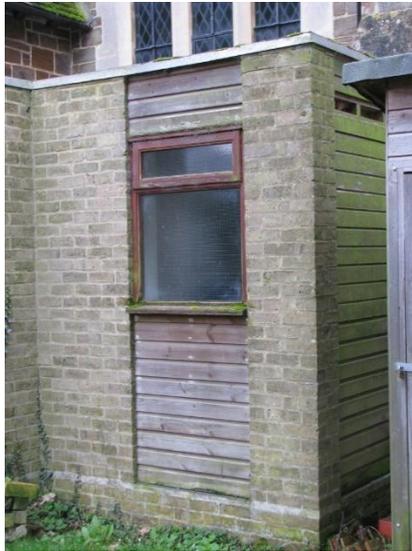
<p>The horizontal boarding to the kitchen &amp; store walls is in need of overhaul and repair, with the missing board replaced.</p>	<p>2/5</p>

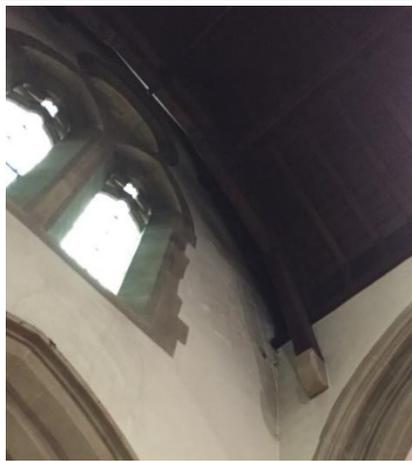
<p>There are some areas of apparent bulging in the plaster at high level internally to the North aisle. These may be historic. A closer inspection internally and externally is recommended &amp; monitoring</p>	<p>2/5</p>

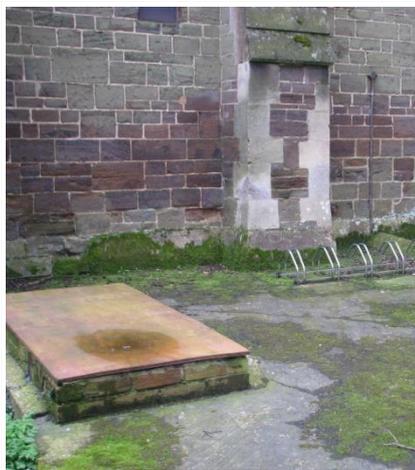
The growth of moss to the dressings and lower walls extends round to the west wall of the north aisle and over the concrete slab covering the redundant boiler room. There are signs of damp on the inside face of the wall which should continue to be monitored until the likely cause of damp penetration is addressed.

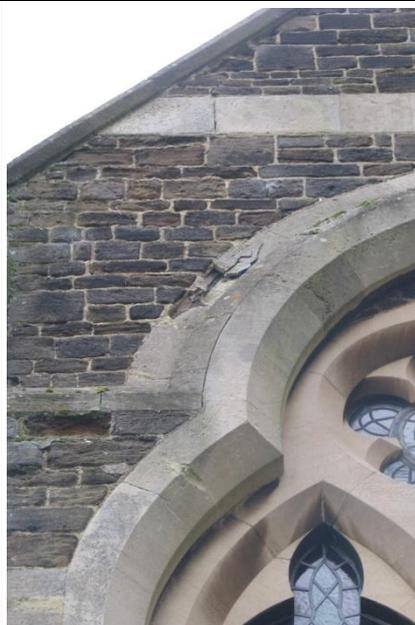
There is no hood moulding to window W15. There instead appears to be a rendered fillet over eroded stone. This render has failed to the upper north side of the window and requires repair or stone replacement.

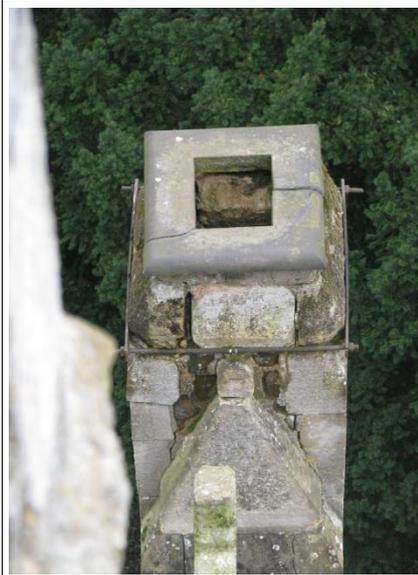
The redundant chimney is in poor condition at high level. There are signs of movement and open joints. Because of the risks associated with potentially falling masonry a close up inspection and possible temporary supports installed is recommended to be carried out as soon as practicable ahead of more permanent repairs.

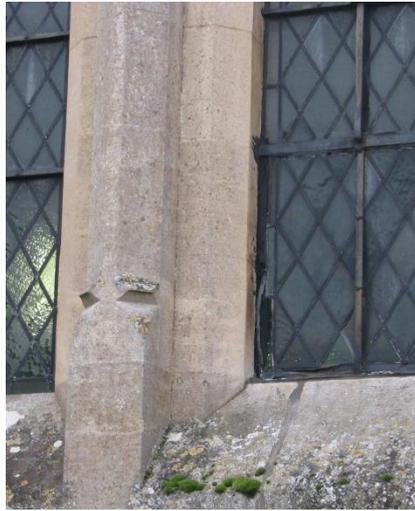
There appears to be a missing quarry to the lower corner of the north light of window W10 (at high level to the east wall of the North aisle). Closer inspection and repair is recommended. The frame in this area also requires some attention.

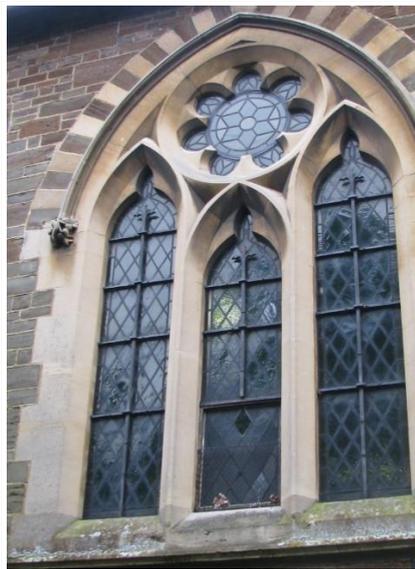
The frame to the opening hopper light in window W13 would benefit from an overhaul.

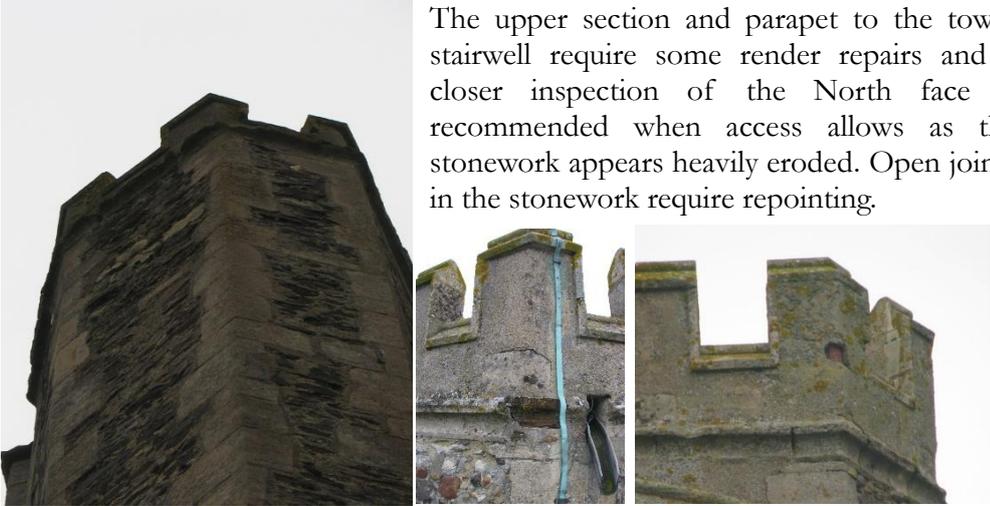
<p>The upper section and parapet to the tower stairwell require some render repairs and a closer inspection of the North face is recommended when access allows as the stonework appears heavily eroded. Open joints in the stonework require repointing.</p>	2

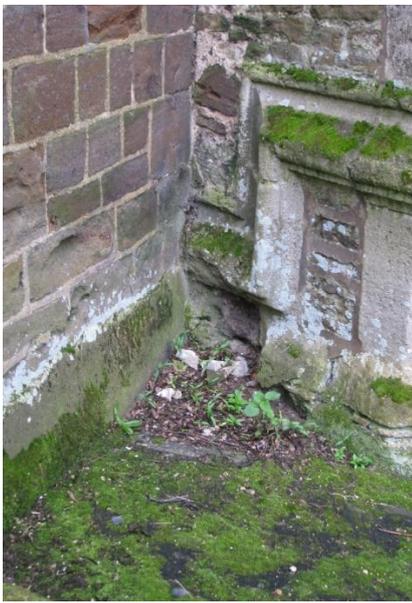
<p>There is erosion at the base of the stairwell which requires attention and along the base of the North wall the moss growth should be removed and the plinth required repointing.</p>	2

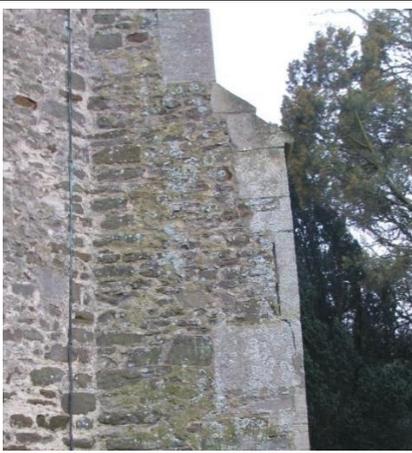
<p>There appears to be an open joint to the one of the quoins of buttress B11 which requires repointing.</p>	2

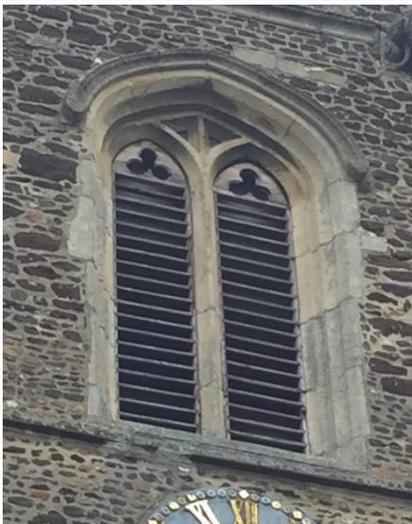
<p>The west jamb of window TW5 appears in variable condition and requires closer inspection. Joints to the stonework appear to require repointing.</p> <p>The louvres to the bell chamber openings would benefit from application of preservative.</p>	3 5

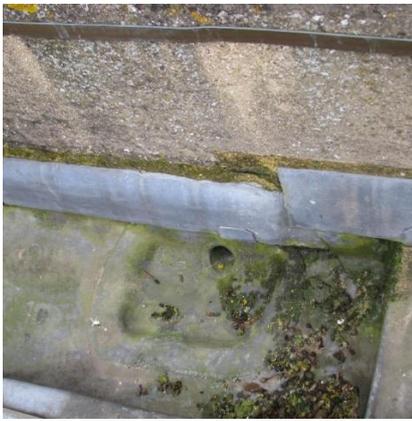
<p>The outlets to the parapet gutter are very small and prone to blocking. Consideration might be given as to how this could be improved. The difficulty is that the outlets pass through the gargoyles.</p>

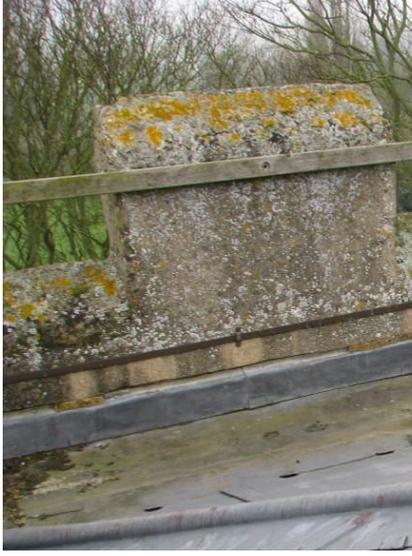
<p>Repointing to the lead flashings is required to sections of the parapet gutter. Stonework is recessing in places and should be monitored Cracks and erosion of the render to the parapet should be pointed up and monitored.</p>

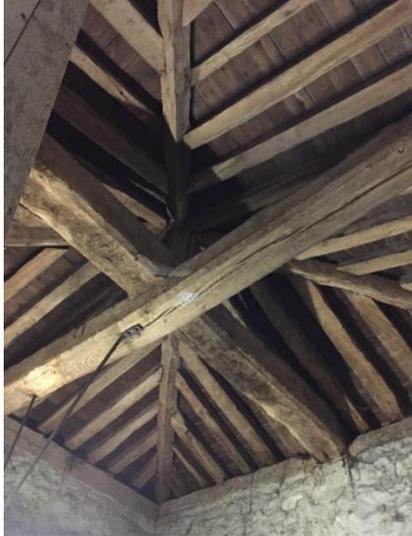
<p>The underside of the roof structure appears satisfactory at present viewed from floor level. It would be prudent to consider arranging for roof timbers (and particularly end bearings) along with the upper floor structures within the tower to be inspected for damp/ infestation by a specialist periodically (say within 10 years or when concerns are raised), and the condition of assessed timbers recorded. Architect can advise further.</p>	4/6

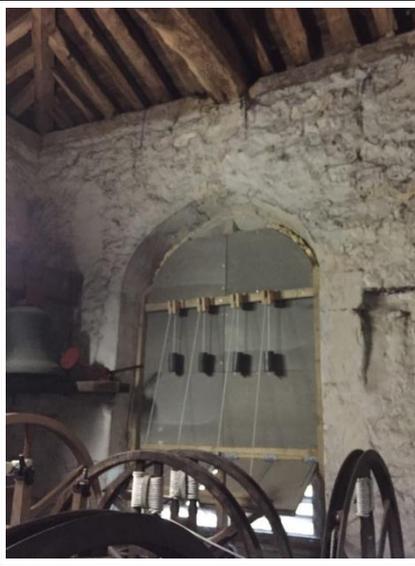
<p>Within the bell chamber, the walls would benefit from a brush down and a light defrass of the loose surface material. The condition of the wall may then be assessed and appropriate repairs identified.</p>	<p>5</p>
<p>Clock room</p>

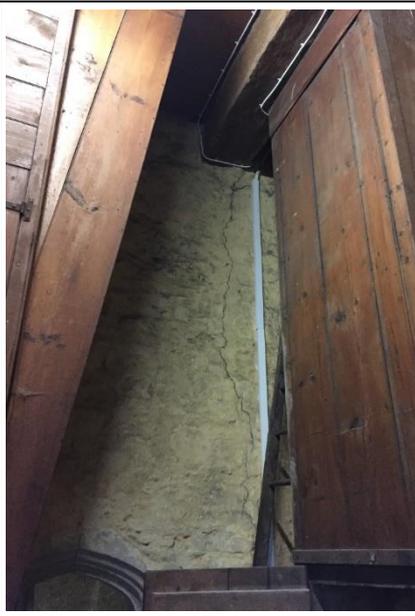
<p>Within the clock room there are cracks over window TW4 &amp; to the North-East and South-West corners. These are reported as having been evident for quite some time, however it would be prudent to monitor and record them seasonally over the next quinquennium so that they may be formally assessed. Any significant changes noted should be reported to the Architect.</p>

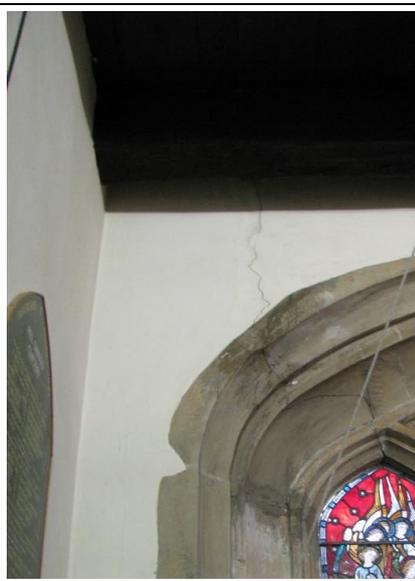
<p>Within the ringling chamber the above vertical cracks (NE &amp; SW corners) extend down through the plastered interior. The crack in the South-West corner extends through the head of window TW2 and there is a smaller crack through the head on the Northern side of the window arch. Monitor as above.</p>

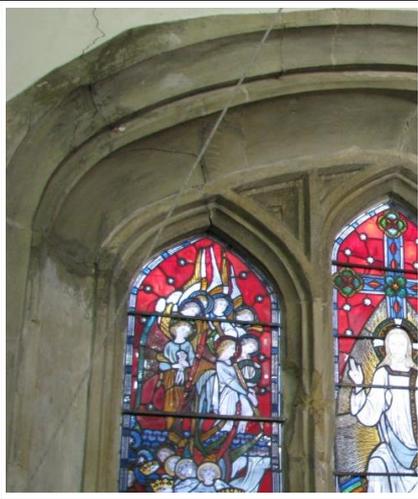
<p>The stonework to window TW2 has been patch repaired. There are a number of cracks, open joints and missing sections that require attention.</p>	3

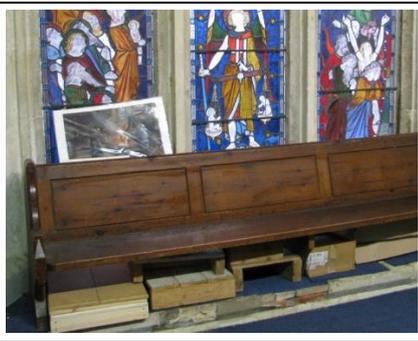
<p>The upstand to the 'cill' of window TW2 at floor level would benefit from attention and re-facing.</p>	4
Tower Base

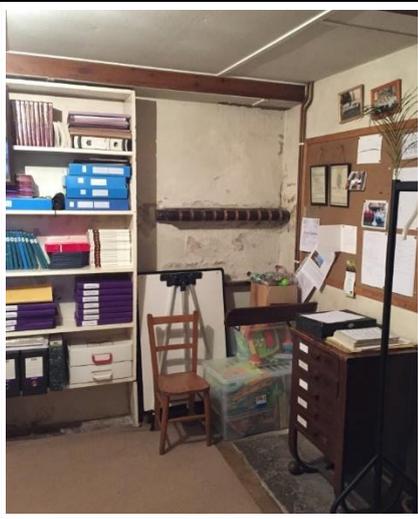
<p>Within the Tower base the walls to the North-West corner and North are showing signs of damp. This may be historic but could also relate to the low level issues exhibited by the North wall externally. Monitor and re-assess once the external issues have been addressed.</p> <p>The ceiling is a painted fibreboard. The age is not known and condition appears satisfactory at present. However it is not known if the possibility of this board containing Asbestos has been investigated, and if not investigation should be carried out to allow the PCC to manage any risk.</p>	5/3  6

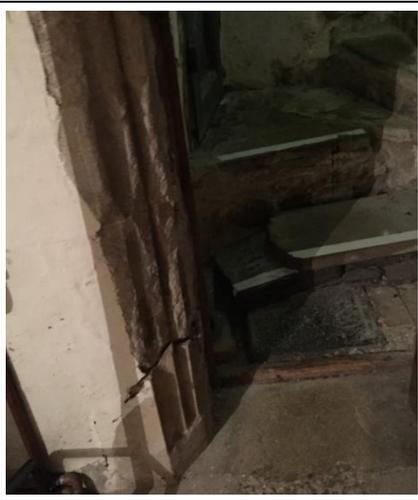
<p>Sections of the stonework to the jambs of tower stairwell door D11 is heavily eroded. Open joints should be repointed, and the stonework would benefit from a de-frass and shelter coat application to slow further erosion.</p>	4

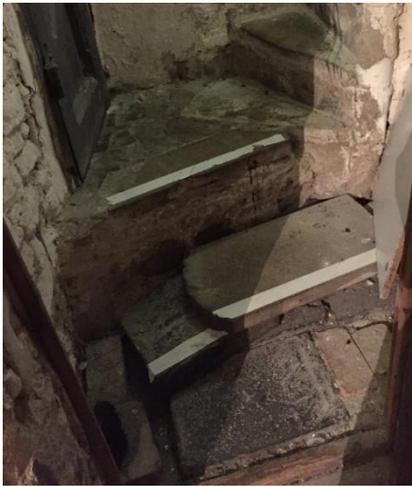
<p>The bottom step to the stairwell is broken and uneven. This is a hazard on a main access route and should be addressed directly, with the tread reset even and to provide an equal rise to the two bottom steps. The floor at the base of the stairs is also in poor condition and need of some attention.</p>	1

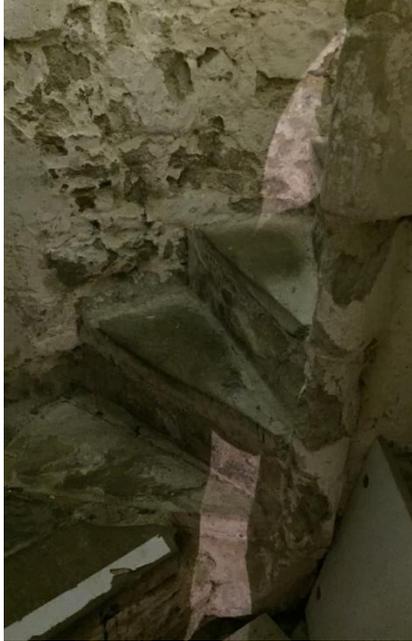
<p>The walls to the lower part of the stair are in a variable condition. This may again be due to the same possible damp penetration in the area to the North of the Tower. The loose paint and render should be removed and finish made good. The visual contrast offered by the walls against the stair treads is currently lacking and combines with limited lighting in this area resulting in walking in the shadow of yourself or others. Ordinarily this might wait to be addressed until the external issues are addressed but even a temporary 'freshening up' would be of significant benefit here.</p> <p>Consideration might also be given to improving lighting and provision of handrail or similar support at least to the level of the ringing chamber due to the frequency of access.</p>	1  2

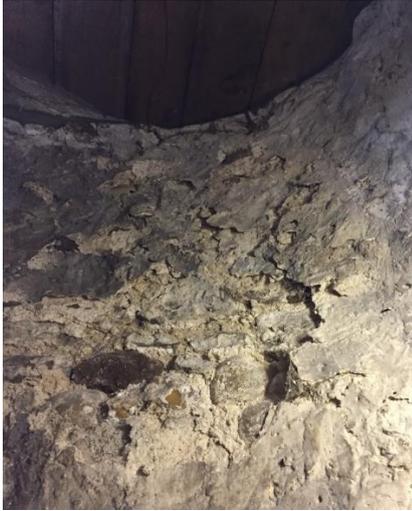
<p>The uppermost section of walling is also showing signs of damp penetraton. External issues with the parapet have been raised earlier and should be addressed before the internal finish here. Monitor in the meantime.</p> <p>There are some minor cracks elsewhere to the walling, notably to the bottom left of the upper stair lancet. The stone to this opening is also heavily eroded but appears adequate at present. The crack should be pointed up and monitored to assess whether it remains active.</p>	4/5  5

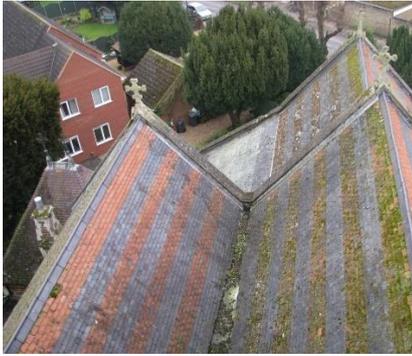
<p>The majority of the main roofs to the Church are of plain tiles laid in coloured bands set behind gable parapets, and appear in generally good order. The catslide roof over the North chapel is of slate, and the roof over the vestry is hipped all round with plain tiles and bonnet hips.</p> <p>The flat roof to the w/c &amp; kitchen was not inspected and its condition should be assessed when the rooflights are next cleaned.</p>	5

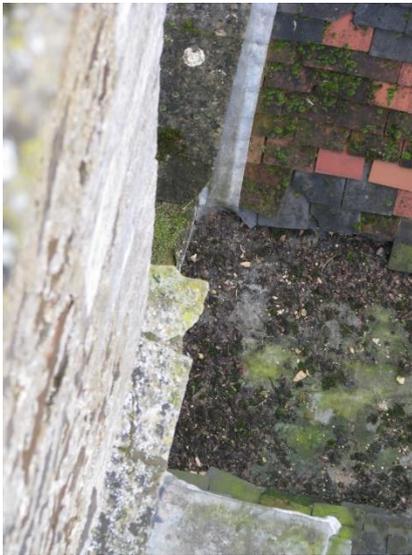
<p>The lead valley between the Nave and North aisle roofs requires brushing through.</p> <p>Arrange for close up inspection of lead valley</p> <p>There are several broken/slipped tiles that require attention, particularly towards the west end of the south face of the North aisle roof.</p>	5 2 2

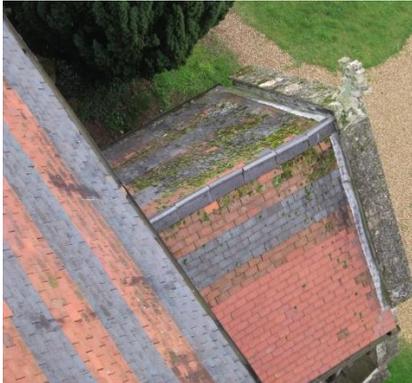
<p>The ridge tiles to the Nave, North aisle and South porch appear slightly unsettled. Closer inspection is required as re-bedding of some of the ridge tiles may be necessary.</p>	2

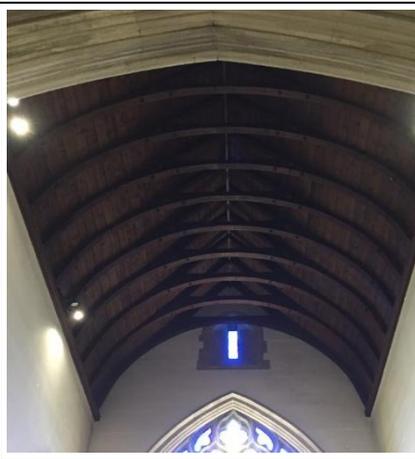
<p>Internally the Nave, North aisle and Chancel ceilings all appear in good condition, though being dark stained and in the shadow a closer inspection is recommended when opportunity allows.</p>	4
	<p><b>NOTE</b> Close inspection of the roof timbers in the church is not possible and this report cannot give assurances that all remain in good order. It is recommended that a</p>

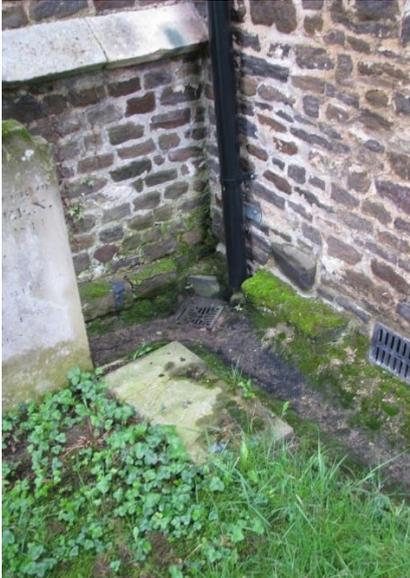
<p>The downpipes are in varied condition. Some such as the lower section adjacent to the South porch have been renewed, whilst many sections require some attention and redecoration before levels of corrosion necessitate their replacement.</p> <p>Where the new section of downpipe adjacent to the south porch has been installed there is no shoe to throw the runoff toward the drainage gully and so the water is now seeping into the wall.</p> <p>There is an open concrete gully around the perimeter of much of the church walls. This needs to be kept clear of moss and growth and maintained in a good condition for it to be effective. Open cracks in the concrete merely serve to retain water against the external walls.</p>	2/5

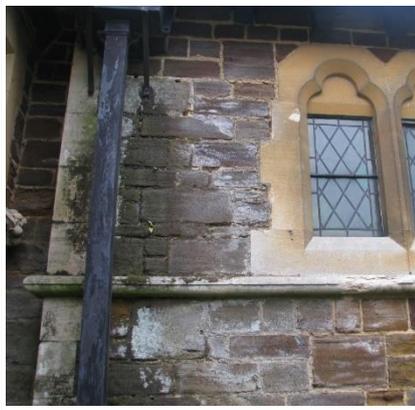
<p>The hopper and downpipe to the East of the Vestry have clearly been leaking for some time and are in need of attention before further damage to the fabric is incurred.</p>	<p>1</p>

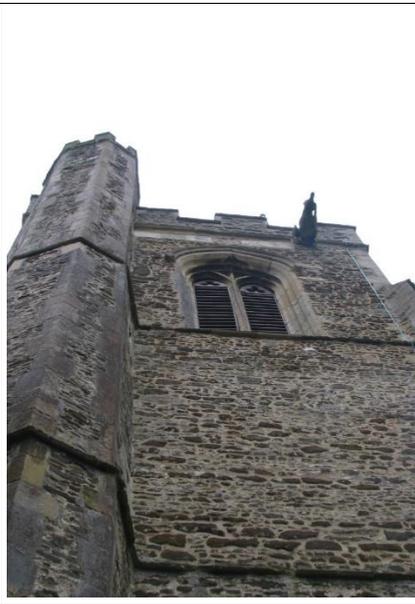
<p>The lack of a downpipe to control outfall from the Tower roof to the North is a likely contributor to the damp issues faced by the North wall of the Tower and West wall of the North Aisle. – Consider as part of the surface water drainage proposals.</p>	<p>1</p>
		<p>It is not known when the surface water drainage system was last rodded – if over five years ago it is recommended that this be carried out directly</p>	<p>5</p>

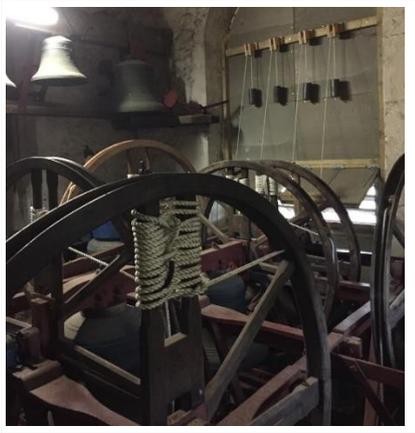
<p>The bellframe appears in reasonable condition. Minor surface corrosion should be brushed down and treated and redecoration of the frame is recommended.</p>	<p>3/5</p>

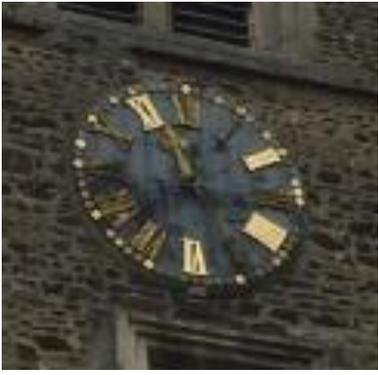
<p>The clock mechanism was inspected in December 2017 by The Cumbria Clock Company. They advised that the strike count wheel non-return spring was broken and needed replacement and that the pulley wheels need to be overhauled with bearings relined.</p> <p>It is not known if this work has been commissioned.</p> <p>The clock face would benefit from redecoration</p>	<p>6</p> <p>5</p>

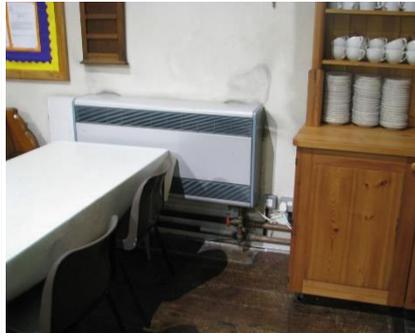
There are patches within the North aisle and vestry where plaster and/or decorations have been disturbed during replacement of radiators? etc. as seen here. Redecoration of these areas would enhance the interior.

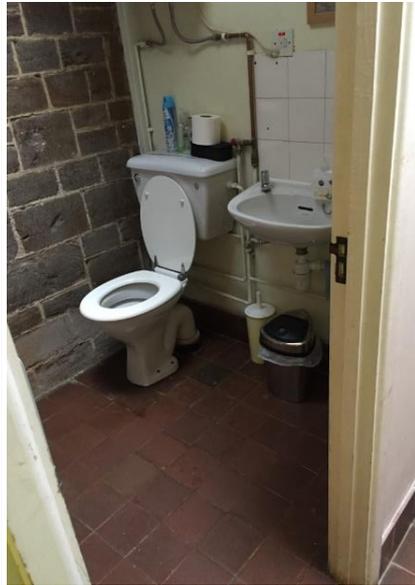
The w/c is rather utilitarian. Wheelchair access is not possible and public access via the vestry which itself has been overrun with the boiler and the necessary storage is also less than desirable.

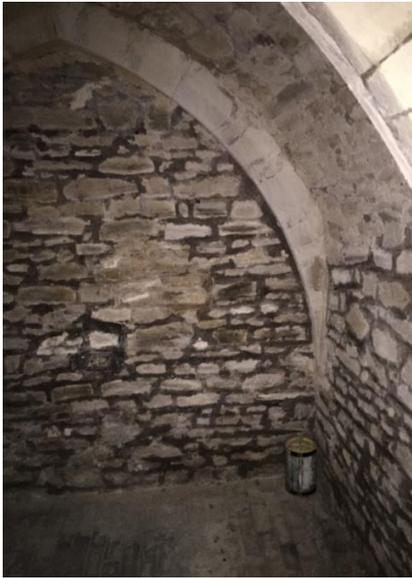
<p>The crypt is accessed via steps set beneath a hatch in the south pew deck to the Nave. It is largely dry and in good condition. The pipe which allows background ventilation from outside is corroded (monitor) and there is the start of growth visible which should be removed. Debris beneath the pew decks should also be cleared where accessible.</p>	<p>5 5 5</p>

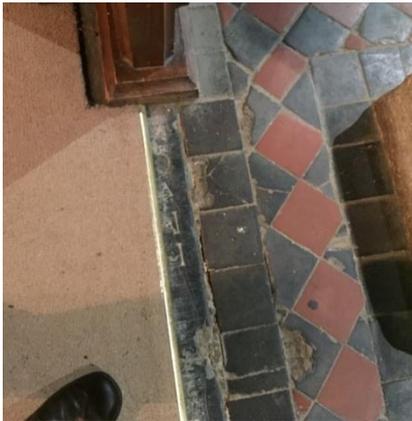
<p>The tiles adjacent to the Tower screen, and within the South porch adjacent to the outside step require attention.</p>	<p>3 2</p>

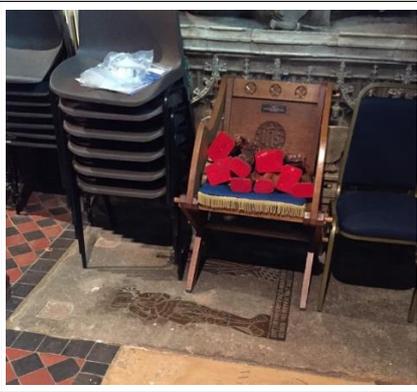
<p>The inset Fisher brasses to the ledger stone within the North chapel should be afforded some protection, and/or this area should no longer be utilised for storage.</p>	<p>1</p>

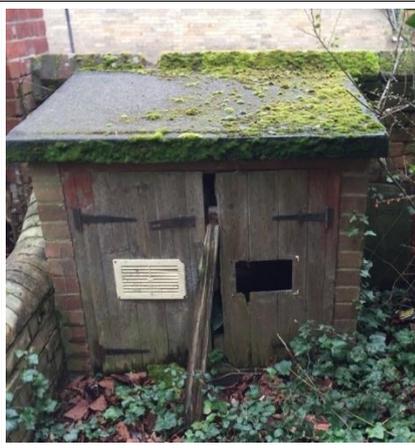
The gas meter cupboard doors and latch require repair/replacement.	2

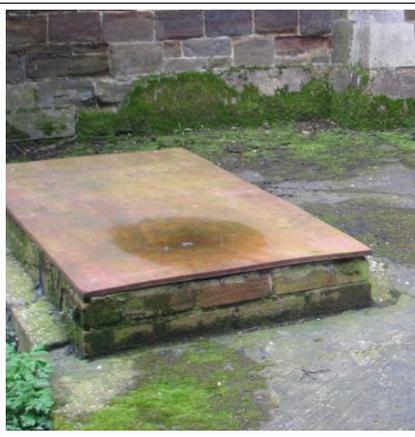
The access hatch to the redundant boiler room to the North of the Tower recently had its metal covering damaged/stolen and a temporary board is currently in place. A permanent solution affording access is required before damp penetration exacerbates the issues suffered by adjacent walls.	2

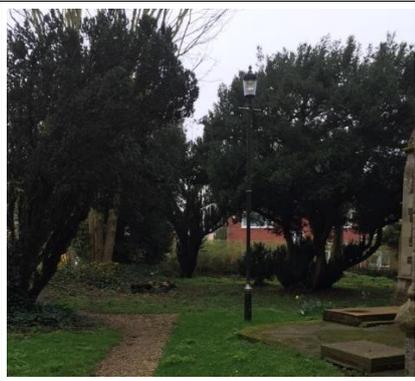
The lamp post to the North-west corner of the Churchyard would benefit from redecoration.	5

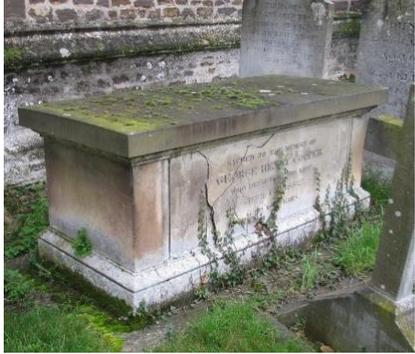
<p data-bbox="767 1579 1366 1760">There is a chest tomb on the south side of the Tower to George Henry Cooper suffering some significant cracking. This should be carefully monitored and the availability of grants etc. for its repair investigated.</p> <p data-bbox="767 1800 1366 1933">The condition of tombs and gravestones should be monitored periodically within the Churchyard and Architect appraised of any issues.</p>	2  5

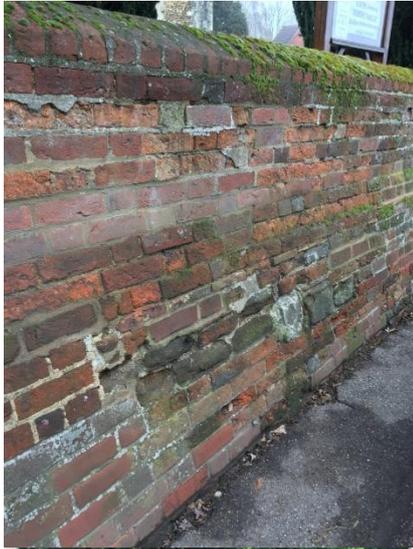
The west wall to the churchyard is in a variable condition. Some bricks have lost faces and are suffering erosion, and there are numerous open joints including to the capping bricks. The moss growth should be brushed back to expose the condition of the wall for assessment, open joints (particularly in the cappings) should be re-pointed to slow further decay and a manageable programme of maintenance of the walls put in place.

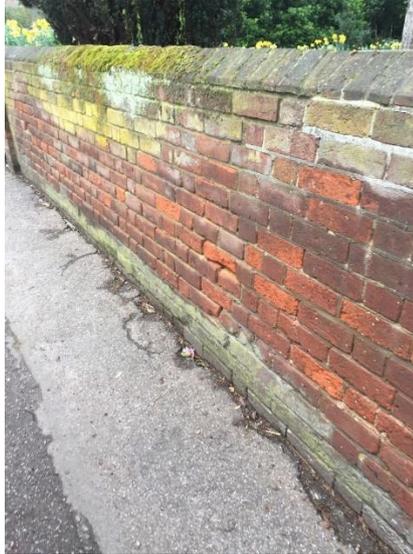
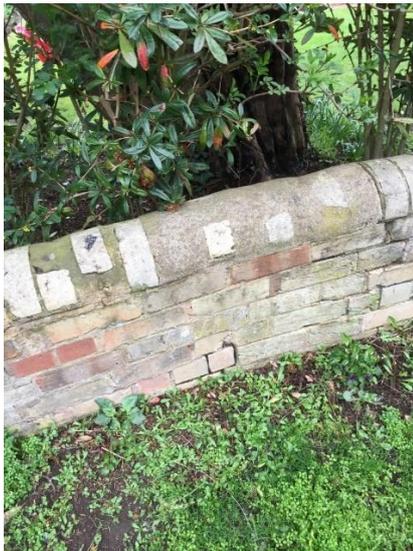
Similarly localised repointing and repairs are required to sections of the North boundary wall.
