**ALL SAINTS' CHURCH  
CLIFTON  
BEDFORDSHIRE**

**QUINQUENNIAL REPORT & RECOMMENDATIONS**

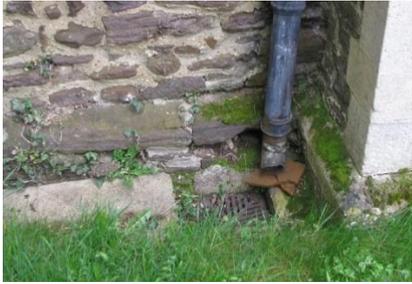
<p>The lower section of wall at the junction with the drainage to the North side of the south porch requires attention, particularly adjacent to the rainwater gully.</p>	2

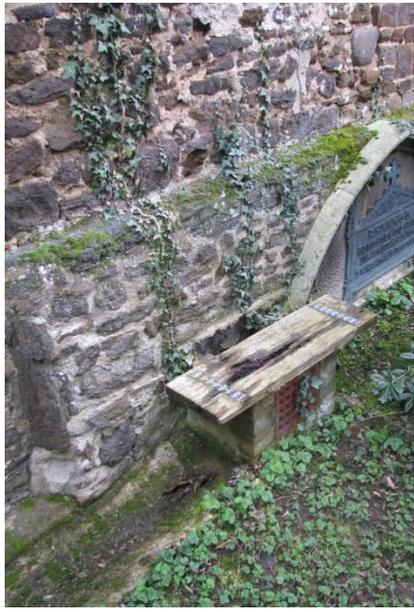
<p>The growth issue is further evident beneath window W2. Growth should be removed and kept clear.</p> <p>The ventilation upstand to the crypt requires a more permanent and effective finish such as a stone capping, and for the drainage channel to be diverted around it.</p>	<p>2/5</p> <p>3</p>

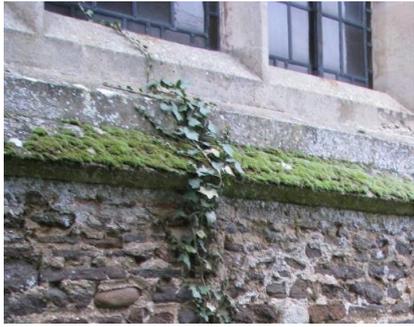
<p>There is some minor erosion to the right hand (from outside) cill stone of window W2 which should be monitored</p>	<p>5</p>

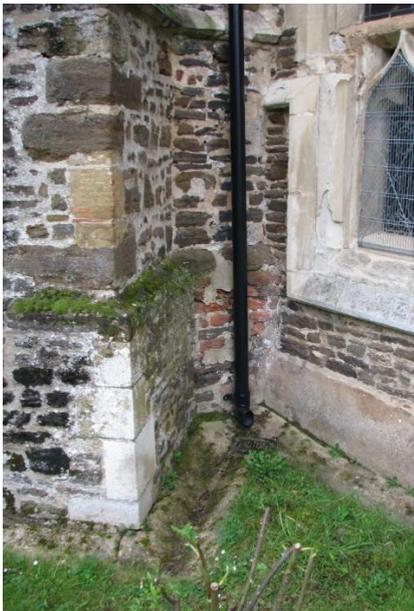
<p>Nave East wall - Cementitious mortar should be removed and open joints should be repointed in lime mortar. Growth should be cleared as elsewhere</p> <p>The upper wall over the chancel roof appears satisfactory from ground level but a closer inspection would be desirable both internally and externally when suitable access permits – as there are some shadow marks in the plaster at high level internally.</p>	<p>2</p> <p>5</p> <p>3</p>

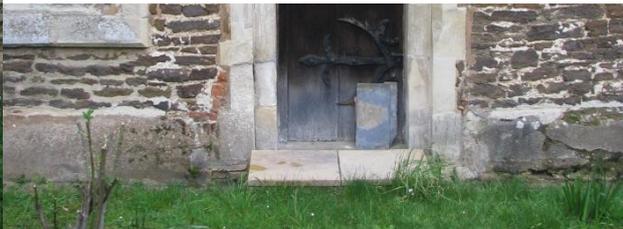
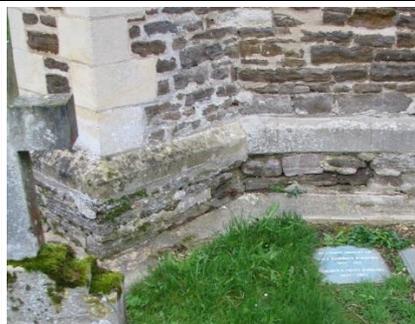
There are further open joints to the plinth of the East wall of the chancel and at high level adjacent to the quoins which require repointing

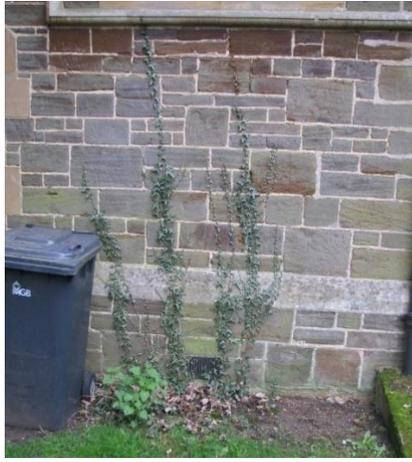
<p>As well as the moss growth to the stone dressings, store ramp etc. growth at low level externally to the north wall of the vestry, kitchen &amp; toilet walls and elsewhere should be removed and kept clear.</p>	<p>2/5</p>

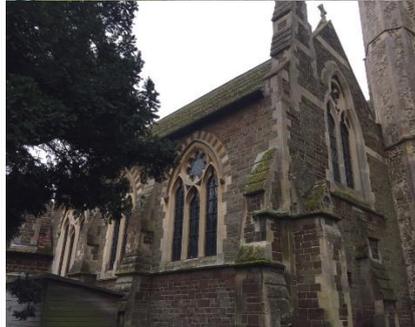
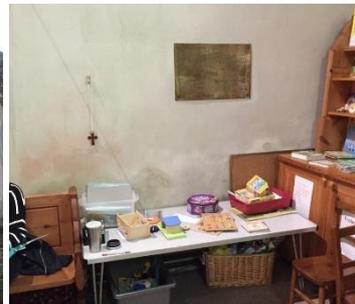
There is no hood moulding to window W15. There instead appears to be a rendered fillet over eroded stone. This render has failed to the upper north side of the window and requires repair or stone replacement.

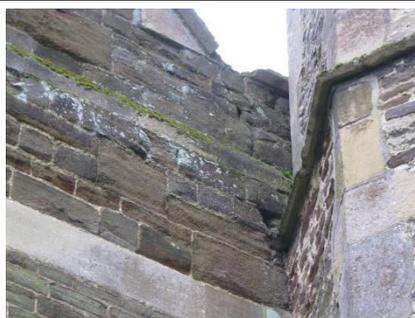
There is a broken section of coping and some stone erosion at the junction between the tower stair and North aisle west wall which require attention, together with some repointing.

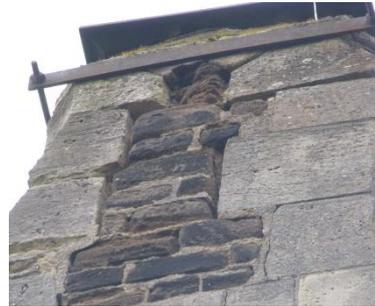
The redundant chimney is in poor condition at high level. There are signs of movement and open joints. Because of the risks associated with potentially falling masonry a close up inspection and possible temporary supports installed is recommended to be carried out as soon as practicable ahead of more permanent repairs.

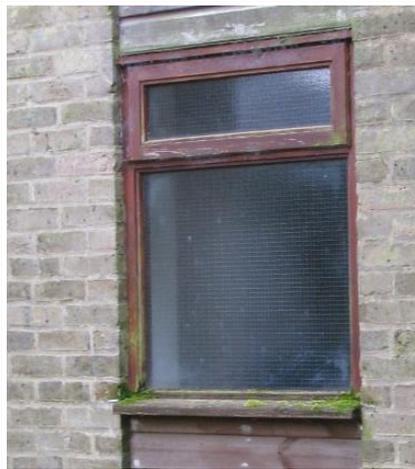
The timber frame to window W10 is in need of an overhaul and redecoration.

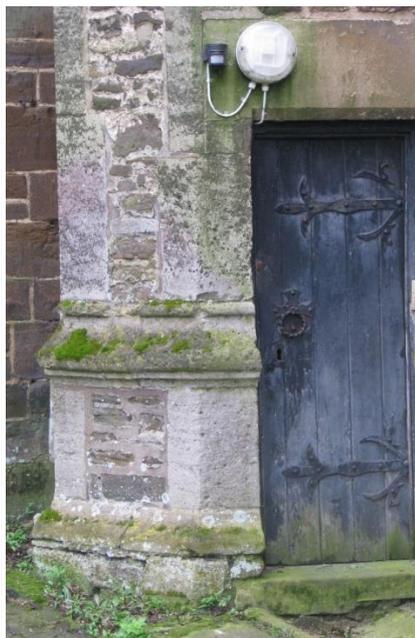
Doors D8, D9 & D10, would all benefit from redecoration.

Consideration might be given as to the addition of a weather bar to each of these doors to afford greater protection to the lower sections of the boards.

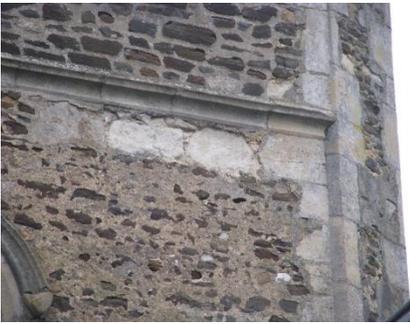
<p>There is some erosion and repointing required at high level on the East face of the Tower below the parapet lower weathering course.</p>	3

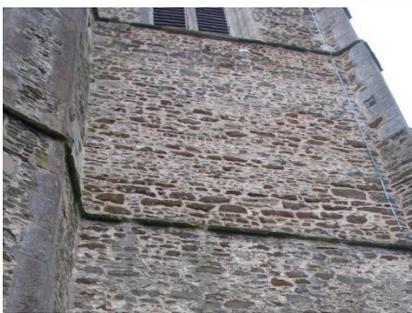
<p>Sections of the mid-level weathering courses to the North face have heavily eroded and require replacement. The upper mid weathering to the South face is in similar condition above the clock. There appears little consequential effect at present and so their condition should be monitored until repairs are carried out.</p>	3 5

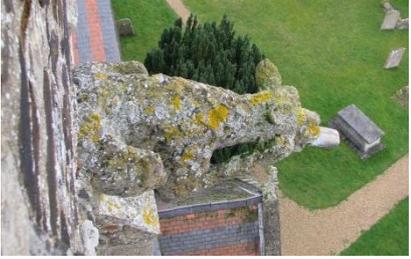
<p>The outlets to the parapet gutter are very small and prone to blocking. Consideration might be given as to how this could be improved. The difficulty is that the outlets pass through the gargoyles.</p>

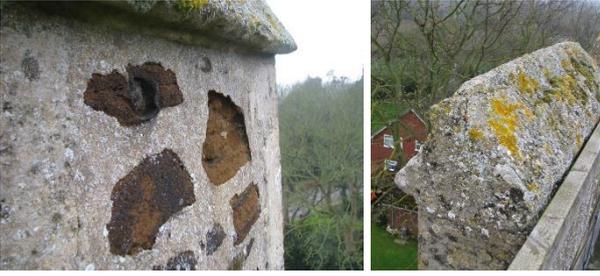
<p>Repointing to the lead flashings is required to sections of the parapet gutter. Stonework is recessing in places and should be monitored Cracks and erosion of the render to the parapet should be pointed up and monitored.</p>

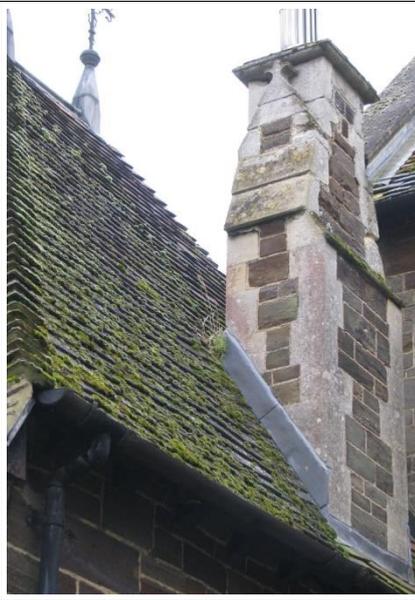
<p>There is significant moss growth to the northern faces of the main roofs and to the vestry roof. This should be brushed clear during a period of dry weather.</p>	5

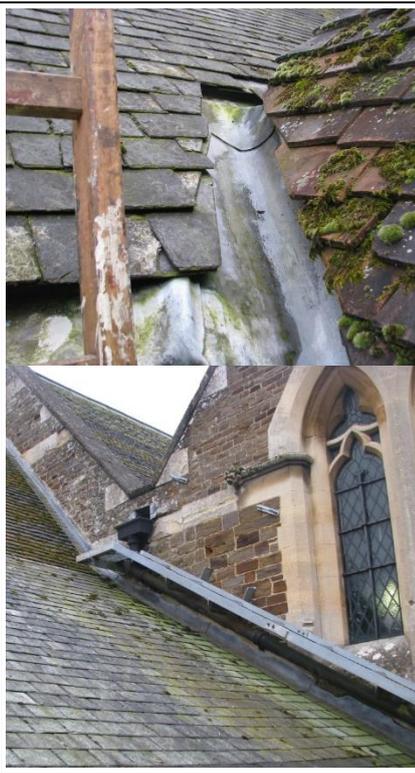
<p>Access to the roofs and particularly the upper 'hidden' valley between the Nave and North Aisle is awkward. Whilst from the point of view of security this is a good thing, access for maintenance other than during dry periods is impractical and unacceptable by modern health and safety standards.</p> <p>It is currently necessary to set a ladder against the gutter of the north chapel and then stretch across to the valley at the junction between the north chapel and vestry roofs. From this point access to the 'hidden' valley is afforded by the fixed ladder to the East wall of the North aisle.</p> <p>Consideration should be given to finding a solution to allow secure access to enable the essential basic maintenance to be carried out safely. The provision of access to the 'hidden' valley via the tower stair might be worth exploration.</p>	3

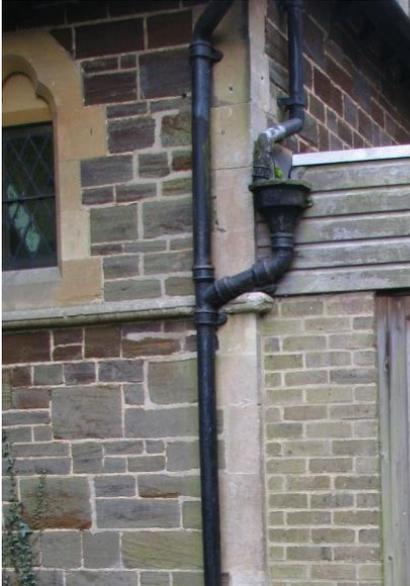
<p>The downpipes are in varied condition. Some such as the lower section adjacent to the South porch have been renewed, whilst many sections require some attention and redecoration before levels of corrosion necessitate their replacement.</p> <p>Where the new section of downpipe adjacent to the south porch has been installed there is no shoe to throw the runoff toward the drainage gully and so the water is now seeping into the wall.</p> <p>There is an open concrete gully around the perimeter of much of the church walls. This needs to be kept clear of moss and growth and maintained in a good condition for it to be effective. Open cracks in the concrete merely serve to retain water against the external walls.</p>	2/5

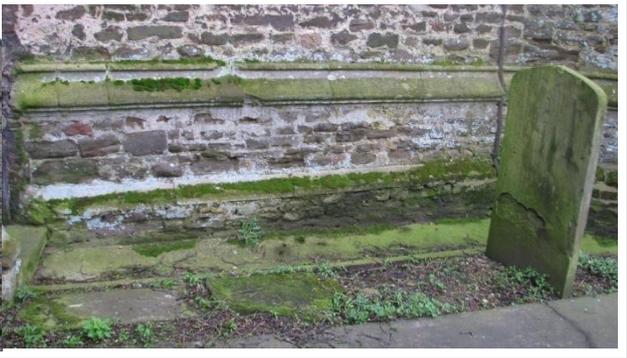
<p>The lack of a downpipe to control outfall from the Tower roof to the North is a likely contributor to the damp issues faced by the North wall of the Tower and West wall of the North Aisle. – Consider as part of the surface water drainage proposals.</p>	<p>1</p>
		<p>It is not known when the surface water drainage system was last rodded – if over five years ago it is recommended that this be carried out directly</p>	<p>5</p>

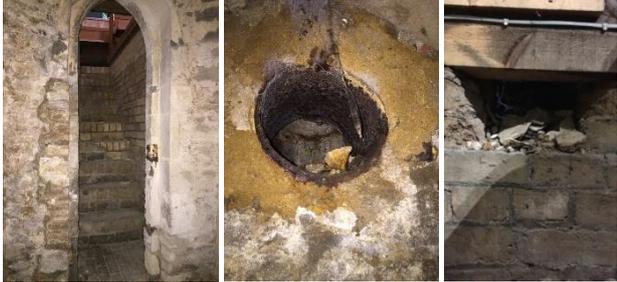
<p>The crypt is accessed via steps set beneath a hatch in the south pew deck to the Nave. It is largely dry and in good condition. The pipe which allows background ventilation from outside is corroded (monitor) and there is the start of growth visible which should be removed. Debris beneath the pew decks should also be cleared where accessible.</p>	<p>5 5 5</p>

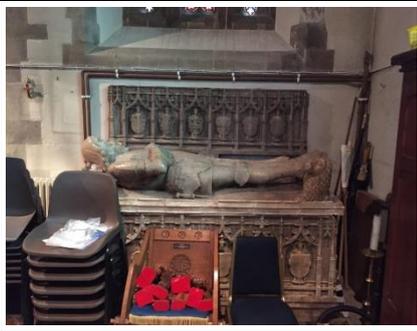
<p>The C16 Fisher memorial tomb is sadly lost amongst the storage</p>

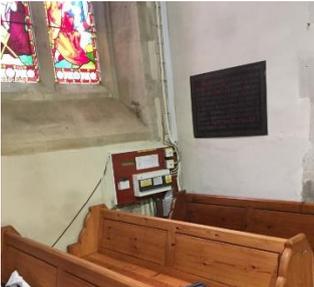
<p>The location of the consumer unit at the back of the Nave in the South-west corner in plain view is rather unfortunate. The PCC might consider how public access to this could be restricted and the visual impact reduced.</p>

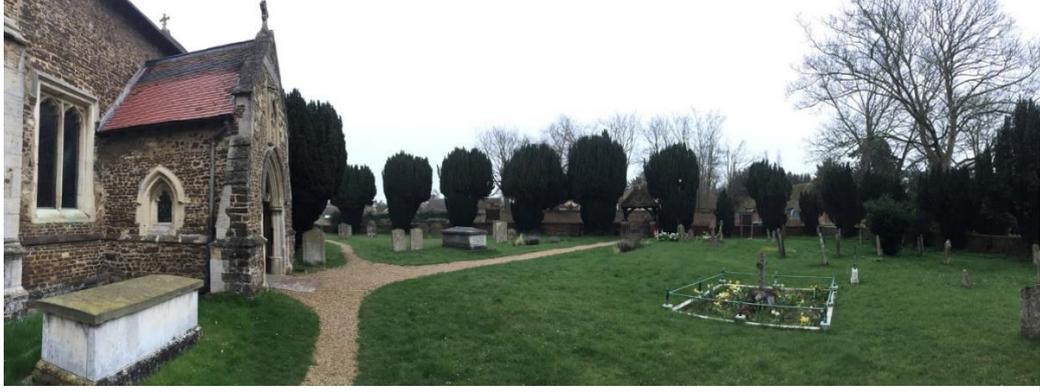
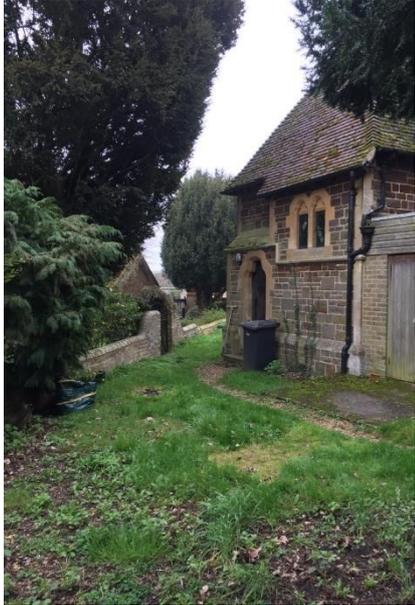
<p data-bbox="767 956 1366 1350">The churchyard is generally well maintained. It is divided into two distinct areas linked by a path adjacent to the rectory garden to the west of the Church. The 'main' churchyard in the close vicinity of the Church itself has graveled paths from the North-East gate, the Lych-gate, the Rectory gate and the 'extended' churchyard that lead to the South porch and are all in good order and relatively weed free. The PCC are currently looking at improving wheelchair access to the South porch from the Lych gate.</p> <p data-bbox="767 1391 1366 1525">The path from the rectory gate extends round the north of the church to the North vestry door. This path would benefit from weeds being cleared.</p>	5

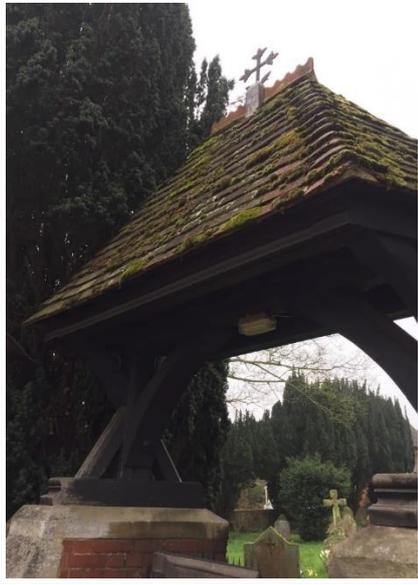
<p>The Lych gate roof would benefit from moss growth being brushed clear. The frame itself appears satisfactory but may benefit from a coat of preservative.</p>	5

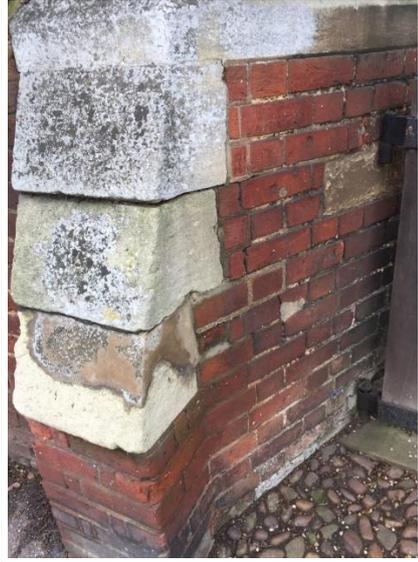
<p>There are signs of some slight movement in the lower section of wall to the south of the Lych gate. The open joints should be pointed up and the situation monitored.</p>	2/5

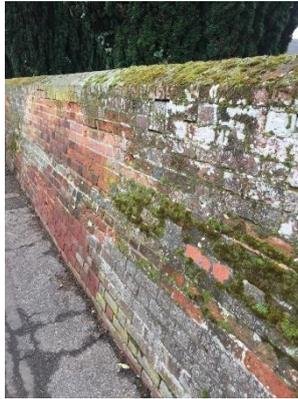
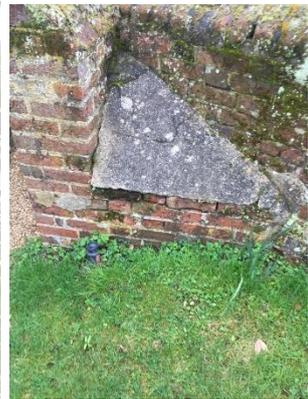
Similarly localised repointing and repairs are required to sections of the North boundary wall.

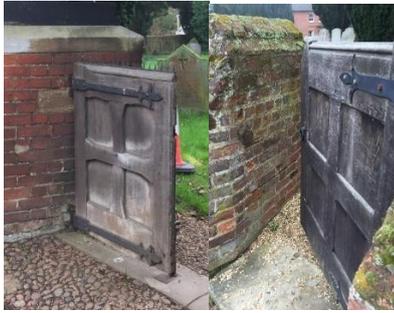
The gates and ironwork to the Lych and North-east gates would benefit from redecoration.	5

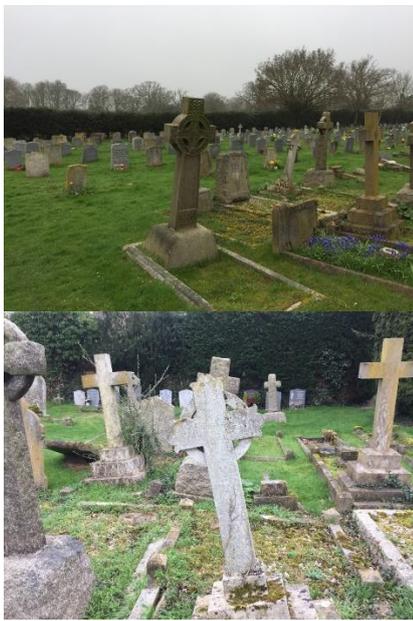
<p>The 'extended' churchyard is generally simply grassed with hedgerow to the boundaries and appears well maintained.</p> <p>There is no formal path.</p> <p>There are a significant number of leaning headstones. These should regularly be checked for stability, and reset as required.</p>	1/5
